(NASA-CR-135196) GRAPHITE FIBER REINFORCED  
THERMOPLASTIC RESINS Final Report (United  
Technologies Research Center) 74 p  
HC A04/MF A01

# Graphite Fiber Reinforced Thermoplastic Resins

United Technologies Research Center

Contract NAS3-20077

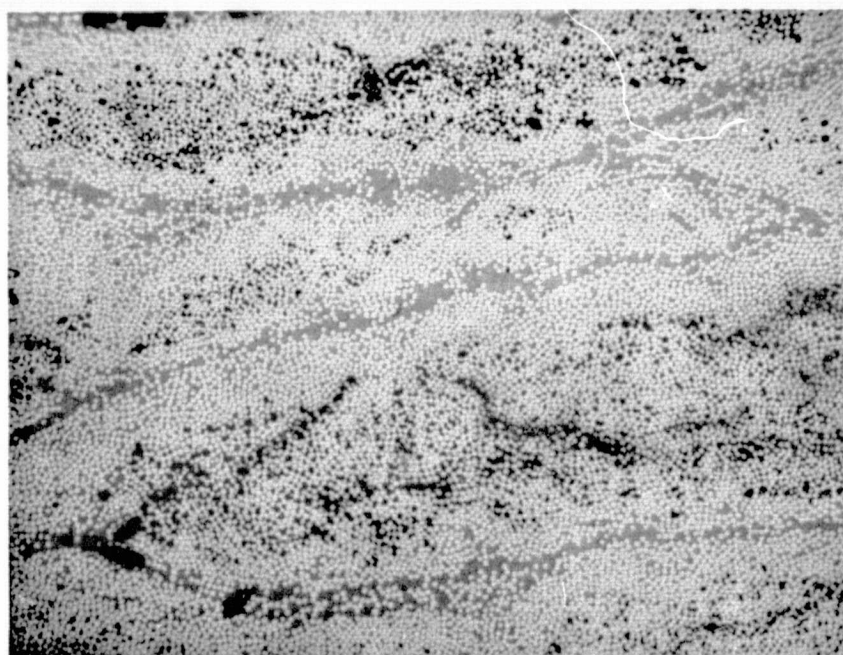
HMS/P-1700 POLYSULFONE COMPOSITE MADE UNDER BASELINE CONDITIONS

A sample from each specimen was polished and examined microscopically. Based on that examination, selected specimens were submitted for flexural and short beam shear testing. The conditions utilized in Ref. 1 for Thornel 300/P-1700 polysulfone were similar to those of run number 2 except the pressure was 6.9 MPa. Figure 1 is a photomicrograph of the baseline specimen of

HMS/P-1700 polysulfone using the Ref. 1 conditions, and shows high degree of porosity. This porosity is substantially greater than observed with the T300 composites and may be due to a greater difficulty in the resin penetrating the larger HMS tow.

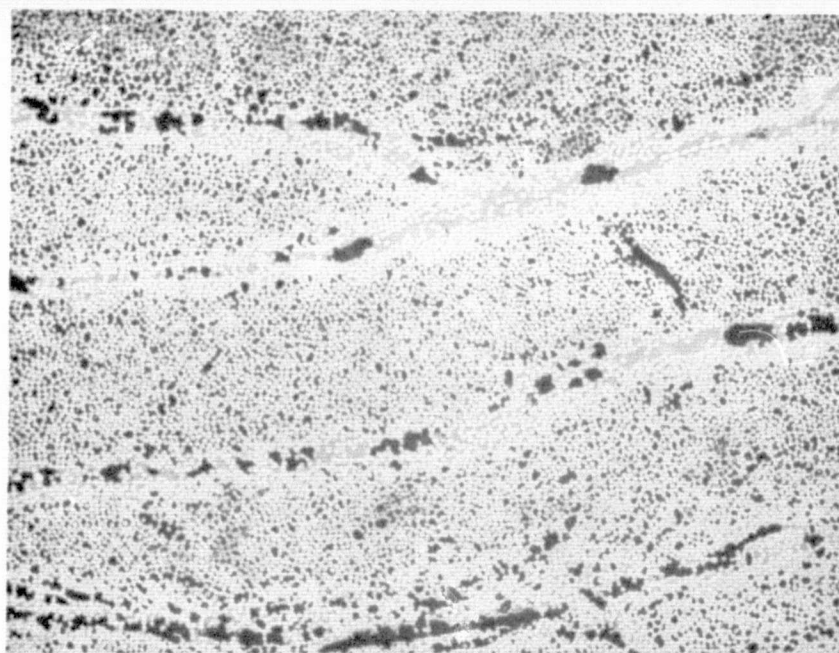
FIG. 2

HMS/P-1700 POLYSULFONE FROM 7.5% SOLUTION

FABRICATION TRIAL NO. 16

One path which was explored to reduce this porosity was to use a more dilute solution thereby lowering the viscosity and improving the chances of the resin fully penetrating the bundle. It was demonstrated that the 7.5% resin solutions did not provide sufficient resin in the composite, and at least an 8.7% solution was necessary. The effect of the lower concentration is shown in Fig. 2. It was also shown that the application of greater pressure, as in numbers 19 and 22 where the latter was hot pressed at a pressure five times higher than the former, did not improve the microstructure of the composite as illustrated in Fig. 3.

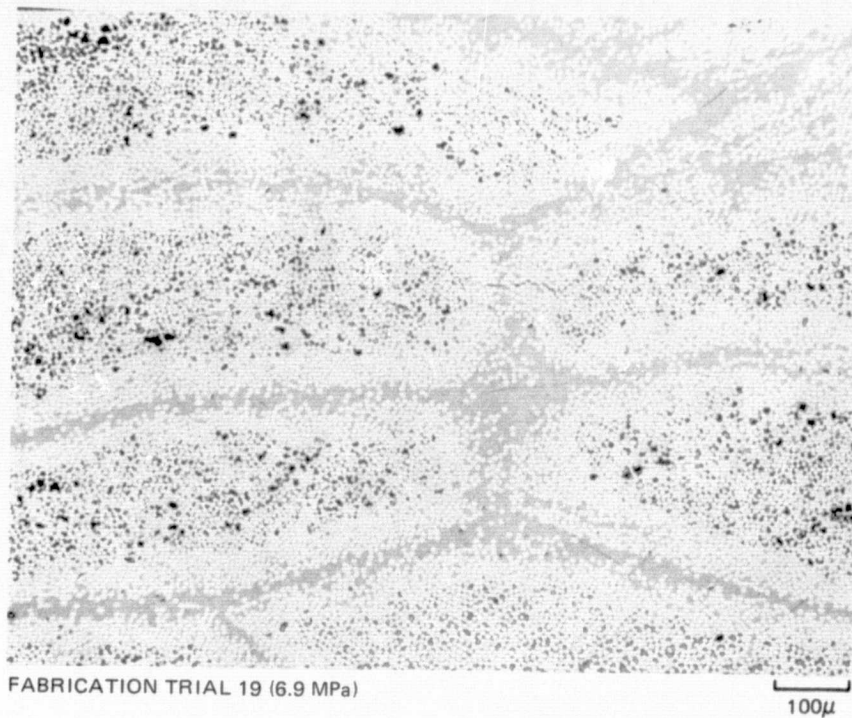
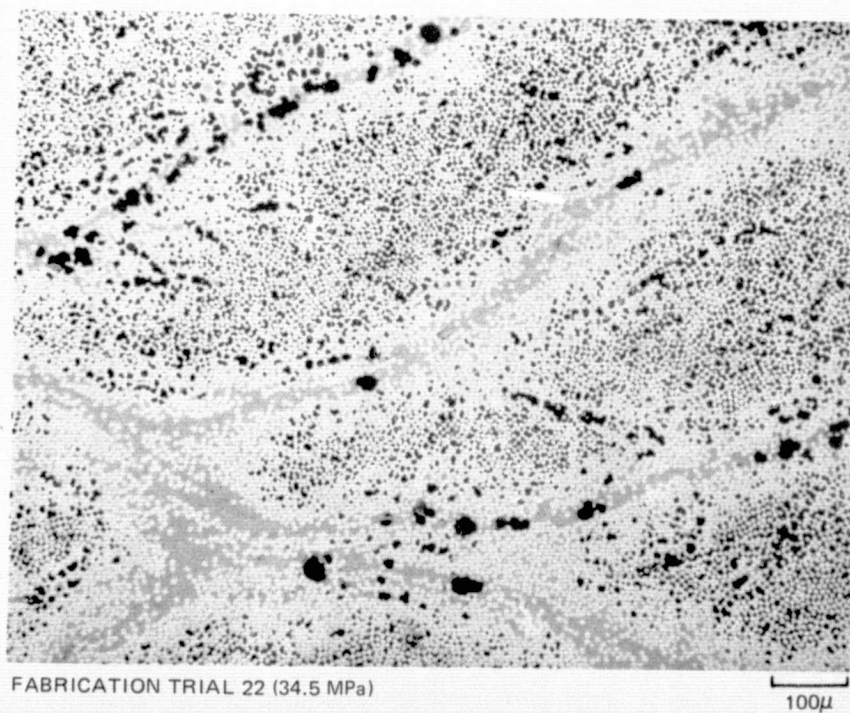
EFFECT OF CONSOLIDATION PRESSURE ON HMS/P-1700 POLYSULFONE

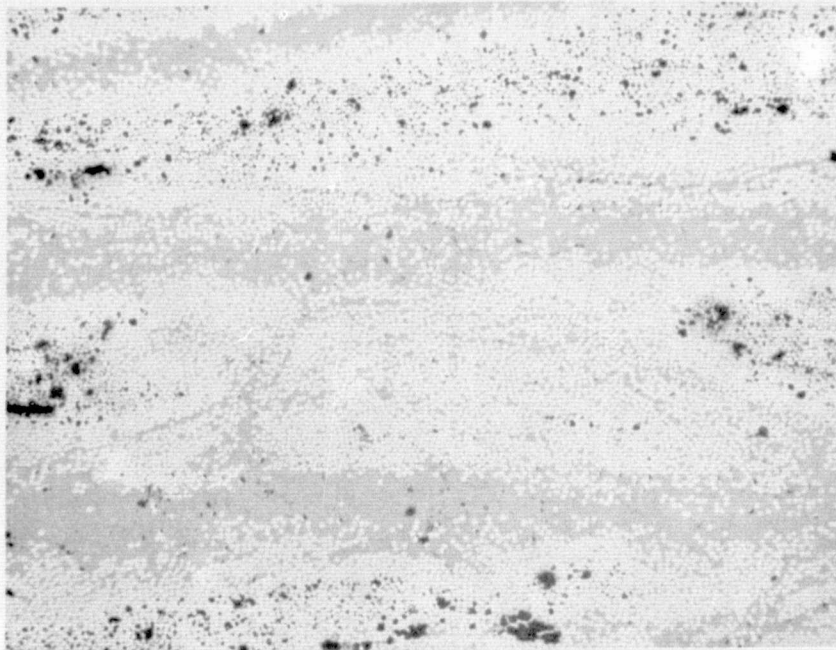
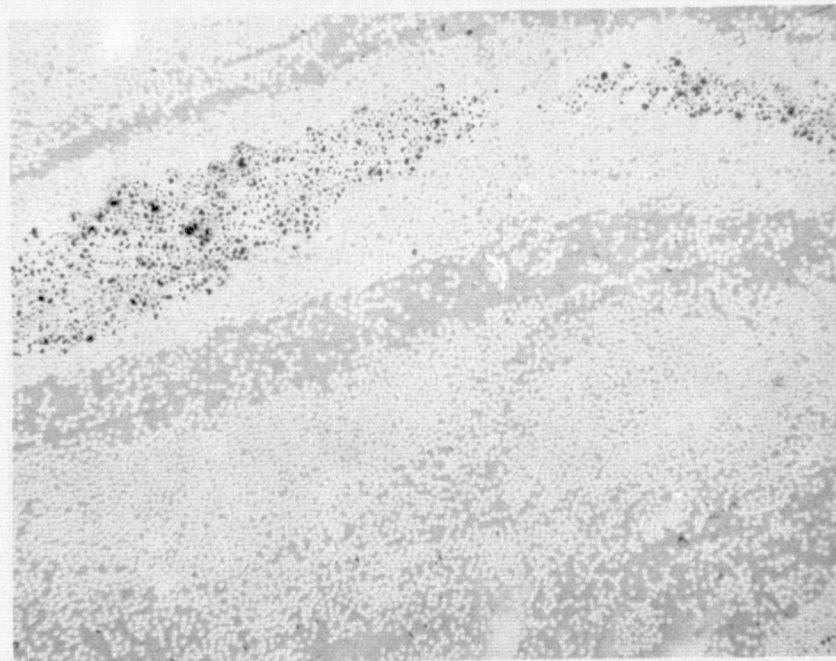
FIG. 4

DRYWOUND AND PAINTED HMS/P-1700 POLYSULFONE

FABRICATION TRIAL 21

FABRICATION TRIAL 23

Fairly good bundle penetration was obtained with the dry winding and hand painting technique employed in composites 21 and 23 as shown in Fig. 4. This possibly resulted from applying the resin to the tow while it was spread out on the drum and/or the penetration/separation which resulted from the brushing operation. This technique is much more time consuming than the wet winding process and does not lend itself to larger scale operations. Consequently, it was felt to be desirable to achieve better infiltration with the wet winding process.

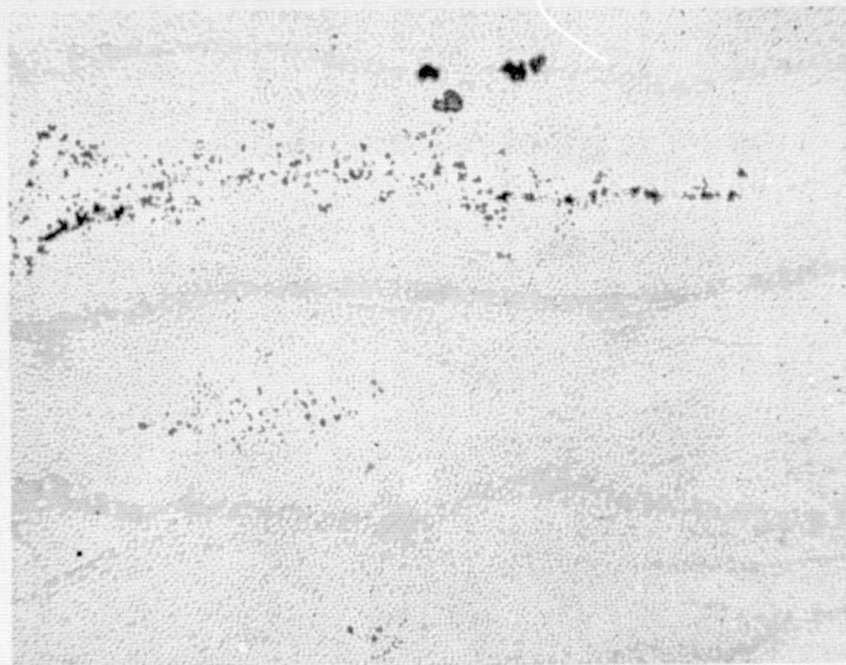
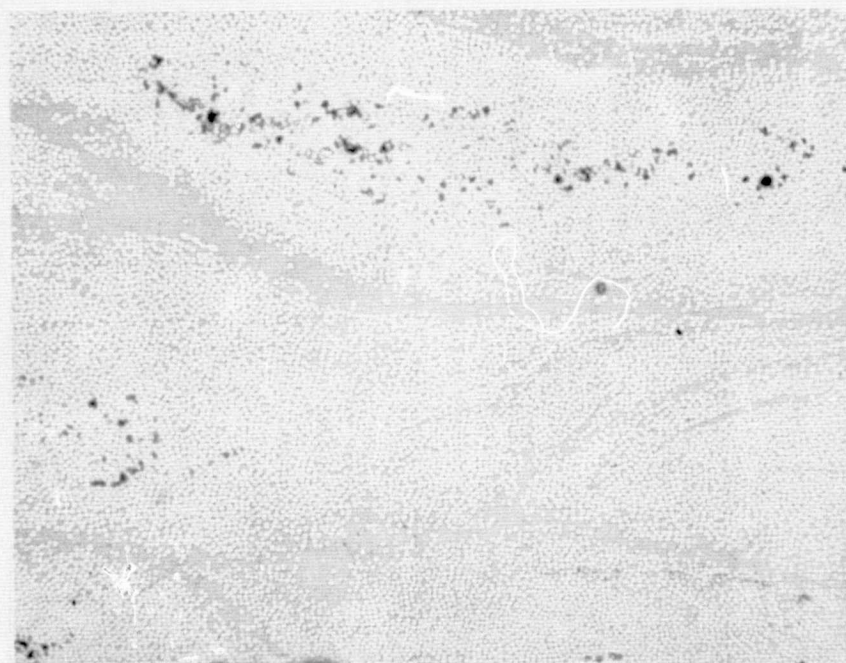
FIG. 5

EFFECT OF IMPROVED TAPE DRYING ON HMS/P-1700 POLYSULFONE

FABRICATION TRIAL 32

FABRICATION TRIAL 34

The series of composites beginning with number 29 and running through 38 was primarily intended to explore the possibility that the porosity was due to entrapped solvent which was not fully removed from the impregnated tape prior to hot pressing. This had encouraging results in that several of the composites had lower porosity than earlier ones. In particular, specimens 32 and 34 shown in Fig. 5 had the best microstructures of any of the polysulfone matrix composites examined to that date. Both exhibited areas which were void free but also had some bundles with internal porosity.

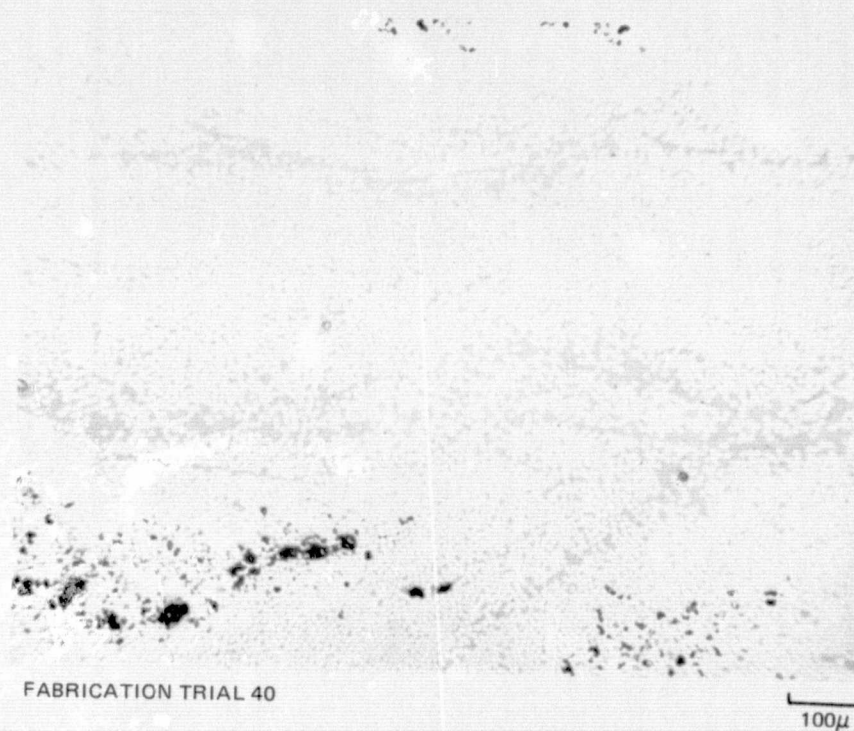
FIG. 6

EFFECT OF TWO DRIVE SYSTEM ON HMS/P-1700 POLYSULFONE

Microscopic examination of the composites indicated that the two drive system tended to make the microstructures more uniform than in the past and that the overall porosity levels were somewhat reduced. However, it was found that composites which were hot pressed for short time periods (2-5 min) still possessed some porosity as in Fig. 6 which shows the specimen from trial 40. Longer duration hot pressing cycles were evaluated (nos. 43 and 44) and in both instances void content was substantially reduced. Microscopic observation revealed sporadic porosity in the bundle centers of the composite pressed for 30 min, and no porosity in the composite pressed for 60 min. Apparently the longer period allowed sufficient time for the resin to flow internally and fill the voids within the bundles. Figure 7 shows the microstructures of the two composites.

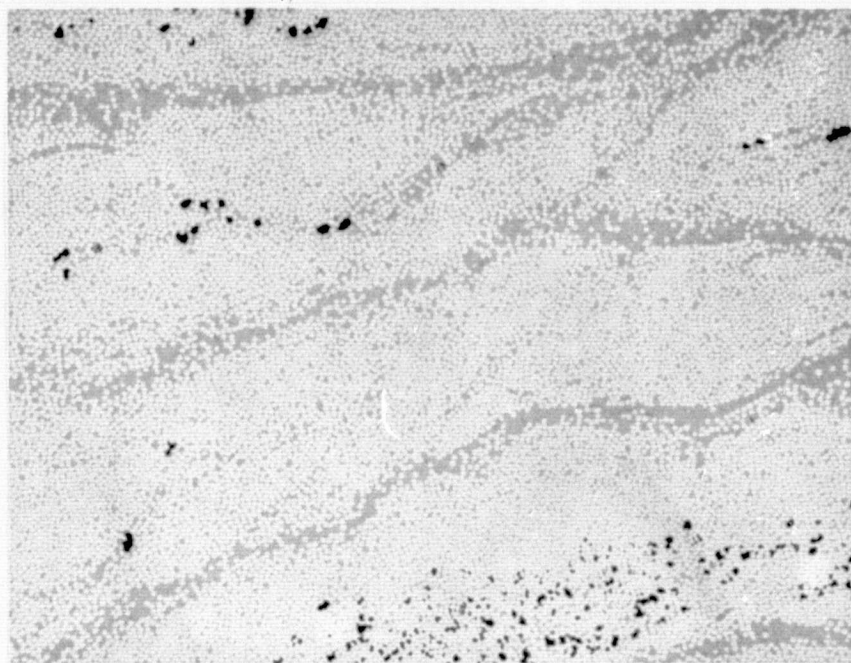
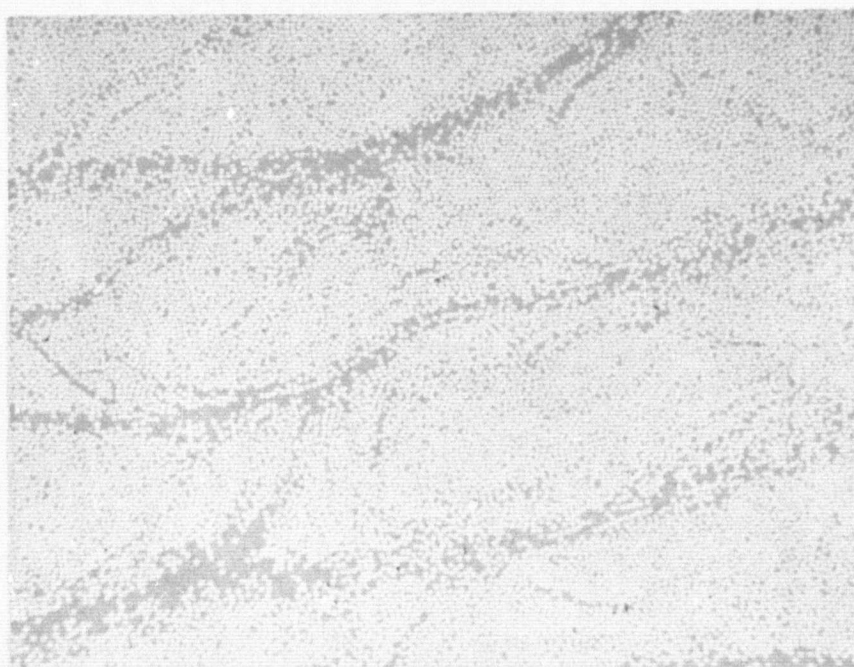
EFFECT OF LONGER PRESSING TIMES ON HMS/P-1700 POLYSULFONE

FABRICATION TRIAL 43(30 MIN.)

FABRICATION TRIAL 44(60 MIN.)

However, the much better microstructure of composite 44 in particular indicated the likelihood of greater reproducibility, and as a result, the longer hot press cycle (60 min at 315°C, 3.4 MPa) was selected for Task II.

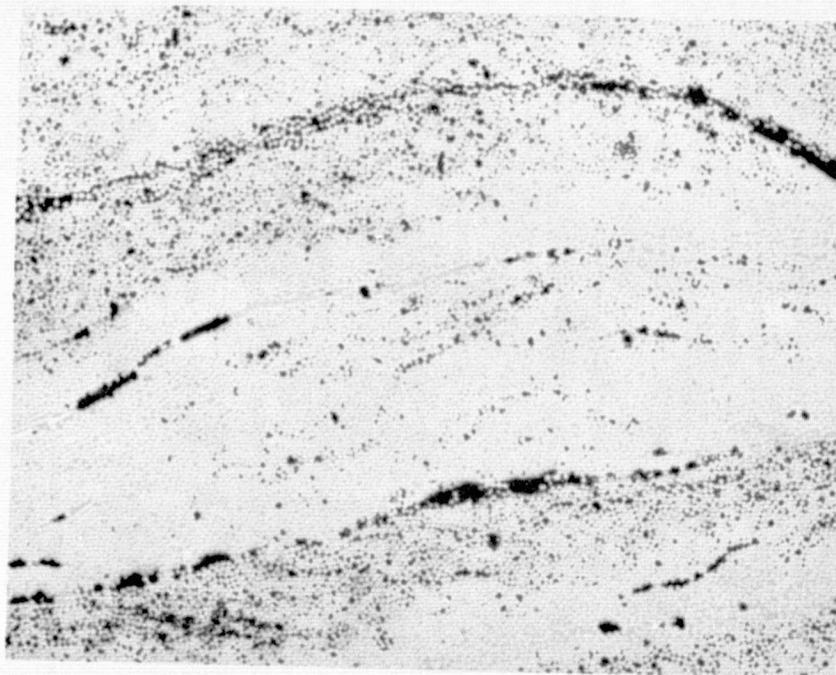
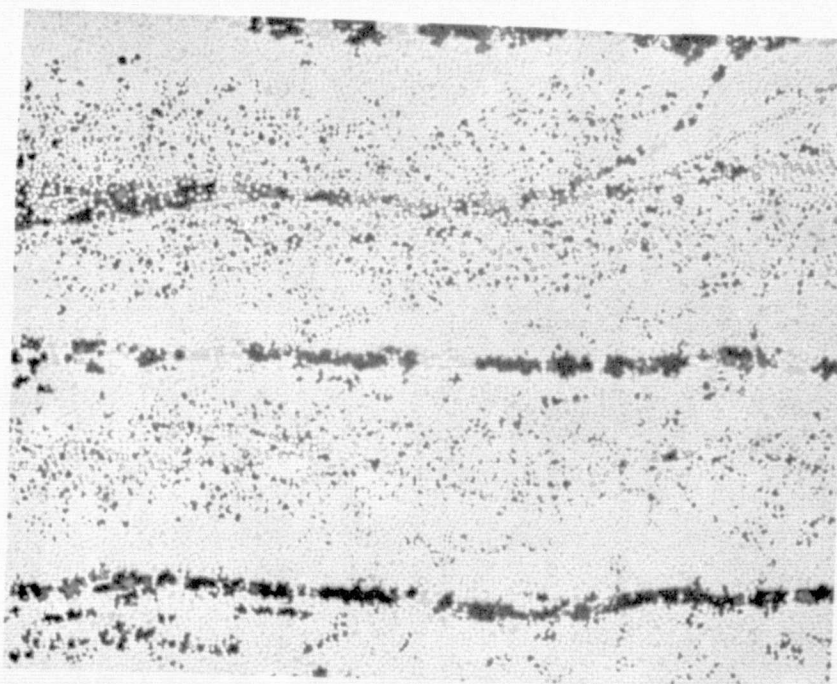
EFFECT OF VARIATION OF TEMPERATURE/PRESSURE ON HMS/300 P POLYETHERSULFONE

FABRICATION TRIAL 1 (315°C, 13.8 MPa)

FABRICATION TRIAL 4 (370°C, 6.9 MPa)

Table III lists the conditions used in the fabrication of HMS graphite composites having 300P polyethersulfone as the matrix. The first four trials were directed toward examining the effect of consolidation temperature and pressure. Photomicrographs of trials 1 and 4 which cover the condition extremes are presented in Fig. 8. In addition to the obvious porosity the composites appeared to be low in resin content and the resin concentration in the impregnating solution was increased in the succeeding trials.

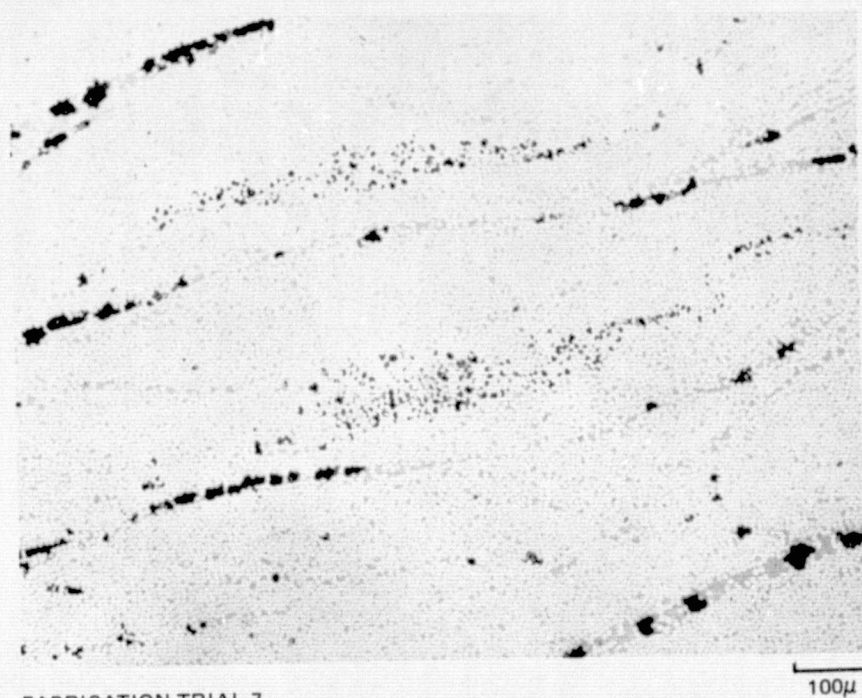
FIG. 9

HMS/300 P POLYETHERSULFONE WITH VOIDS BETWEEN BUNDLES

FABRICATION TRIAL 7

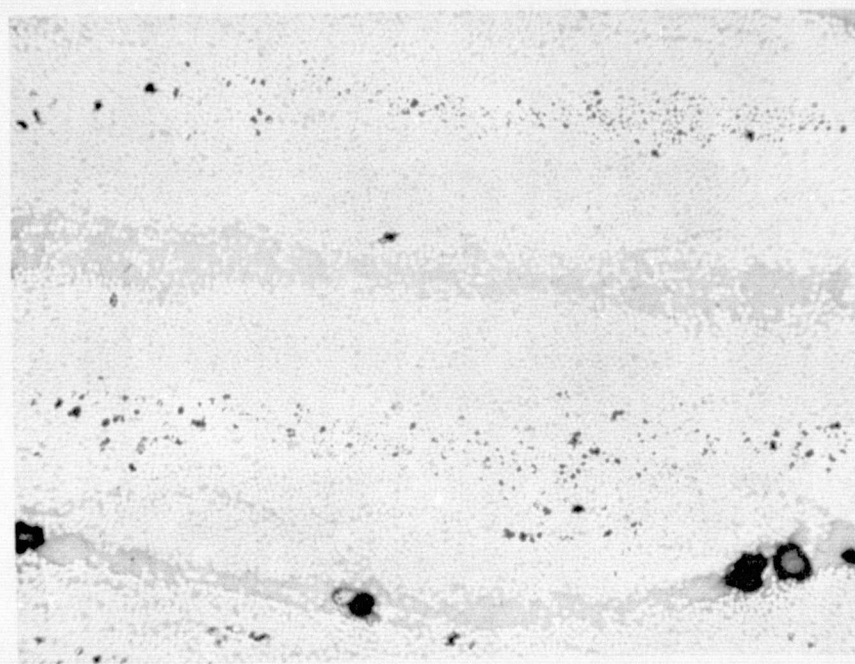
HMS/300 P POLYETHERSULFONE WITH 4 HRS. AT 150°C DRYING

FABRICATION TRIAL 13

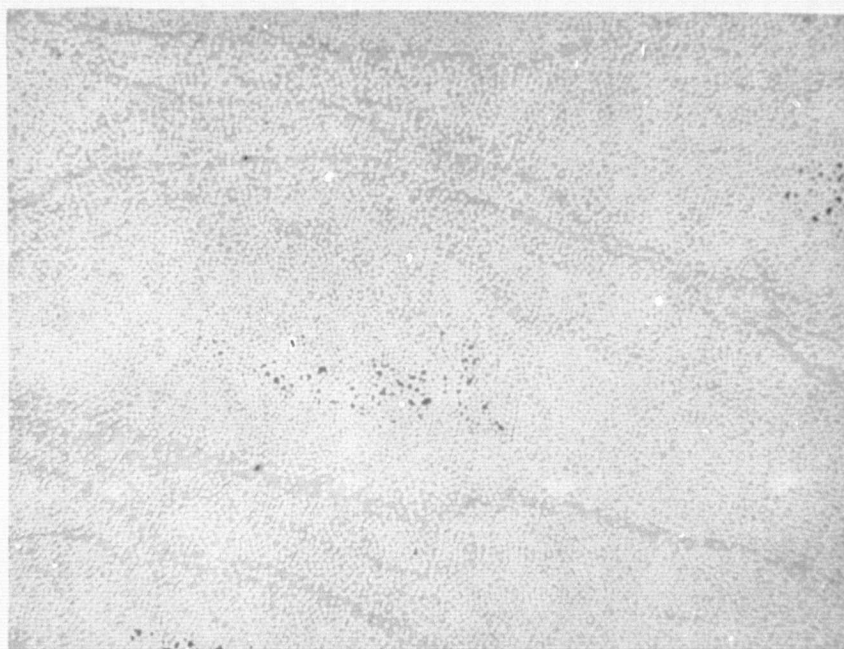
FIG. 11

OPTIMIZED HMS/300 P POLYETHERSULFONE COMPOSITE

FABRICATION TRIAL 20

The final optimization came about by utilizing the driven roller prior to impregnation (no. 14), increasing the resin content in the impregnating solution to 12.5% (no. 16), and by hot pressing for 60 minutes. This resulted in a nearly void-free microstructure as shown in Fig. 11 which is a photomicrograph of composite 20. Although some porosity is evident in the bundle centers in Fig. 11, much of the composite was totally free of voids.

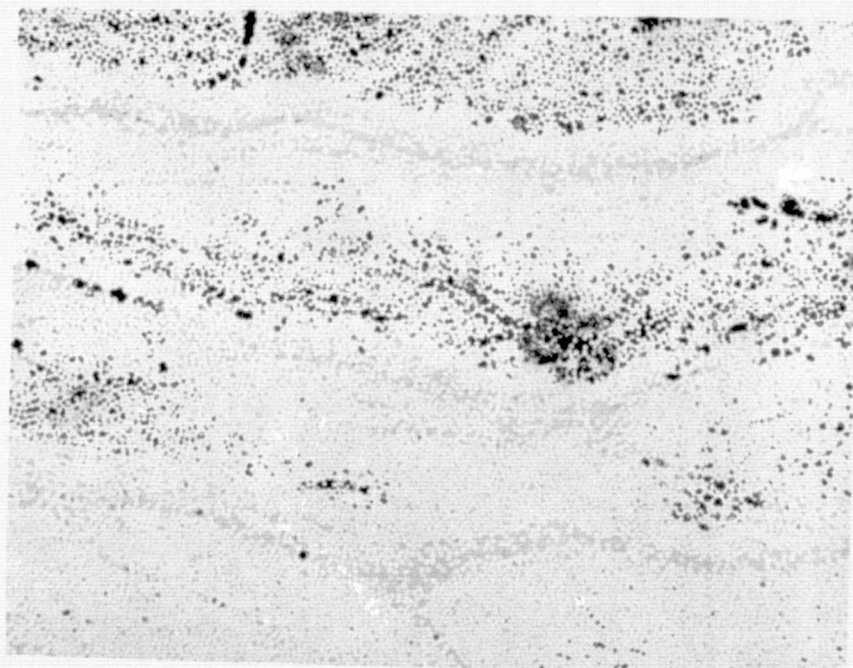
BASELINE FABRICATION PROCEDURE FOR HMS/360 POLYARYLSULFONE

The fabrication variations investigated with Astrel 360 matrix composites are given in Table V and the mechanical properties measured on selected laminates are given in Table VI. The conditions listed for fabrication trial 1 were the same as those used in the fabrication of polyarylsulfone matrix composites in Ref. 1. The photomicrograph of the specimen, shown in Fig. 12, indicates the porosity in the center of the filament bundles. Initial variation in drying time (Fig. 13) and temperature/pressure combination in hot pressing (Fig. 14) established the apparent need for a long drying cycle and a high hot pressing temperature. However, the longer drying cycle used in trial no. 2 did not result in a significant improvement in void content as indicated in Fig. 13, and the desirability of a high hot pressing temperature was concluded because of the poorer results shown in Fig. 14 for fabrication trials 5 and 6.

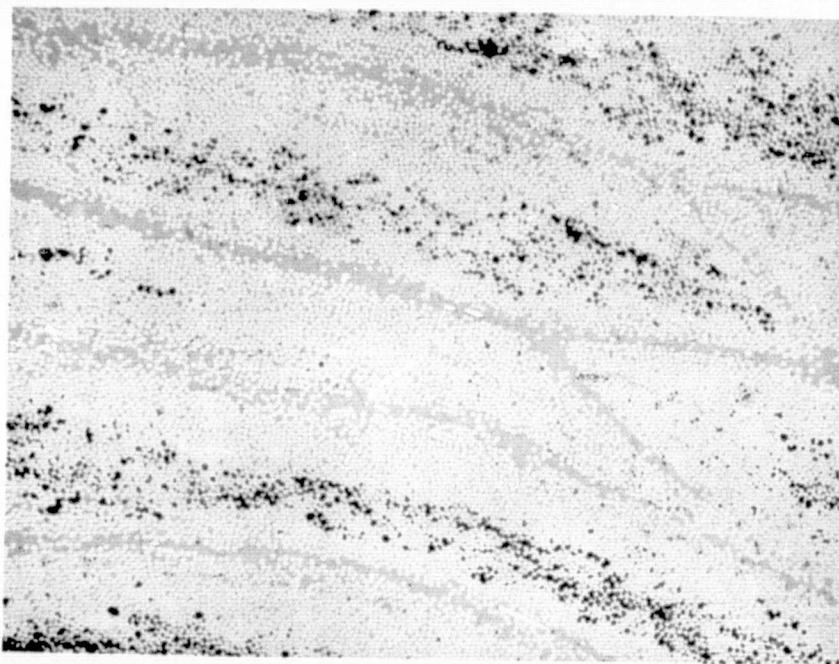
HMS/360 POLYARYLSULFONE WITH 4 HRS. DRYING AT 150°C

FABRICATION TRIAL 2

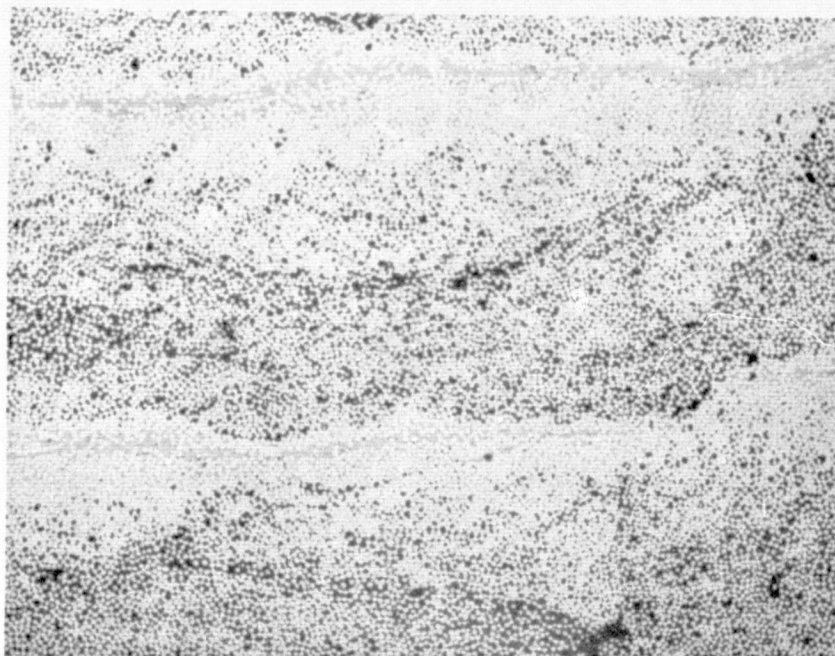
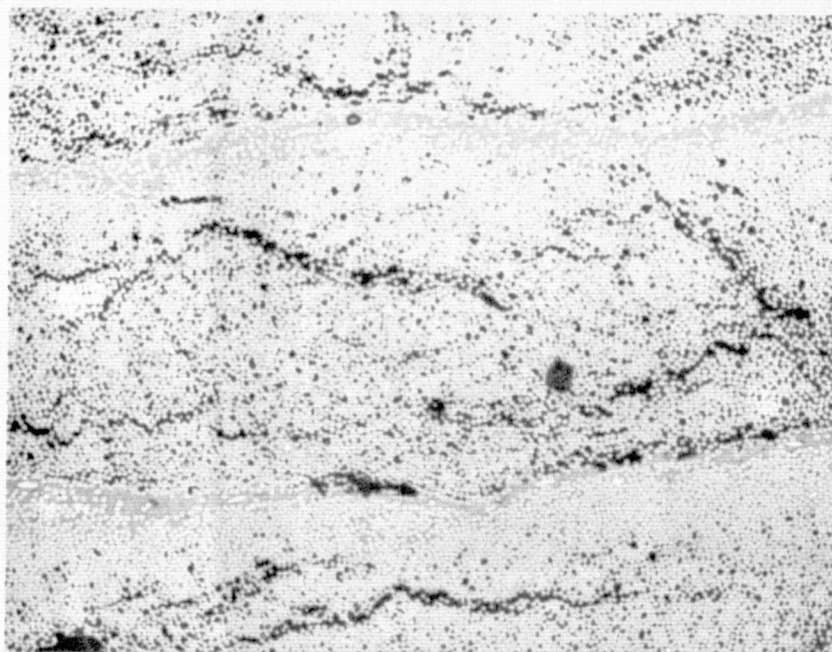
# VARIATIONS IN CONSOLIDATION PRESSURE AND TEMPERATURE IN HMS/360 POLYARYLSULFONE

FABRICATION TRIAL 5 (343°C, 13.8 MPa)

FABRICATION TRIAL 6 (315°C, 13.8 MPa)

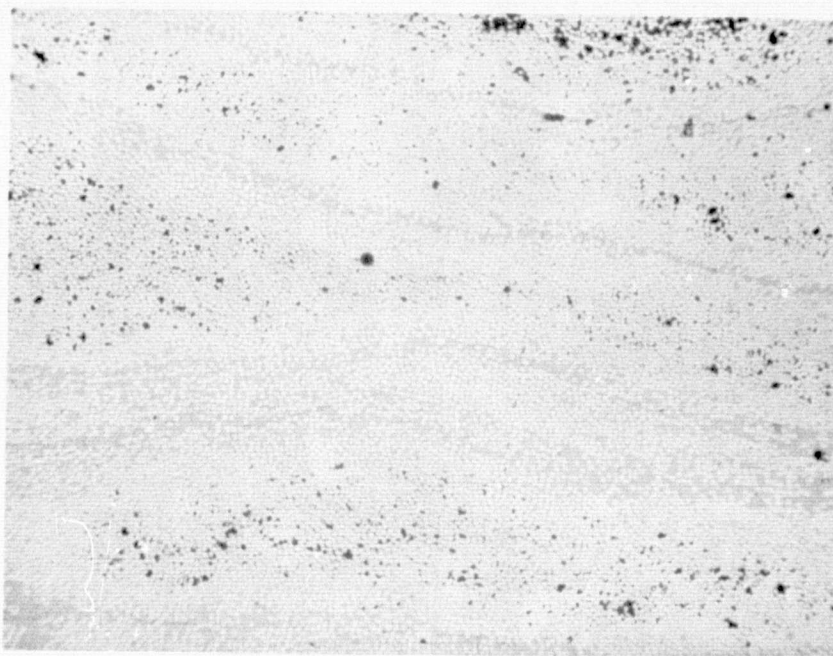
FIG. 15

HMS/360 POLYARYLSULFONE CONSOLIDATED AT HIGH  
TEMPERATURE,HIGH PRESSURE

FABRICATION TRIAL 8

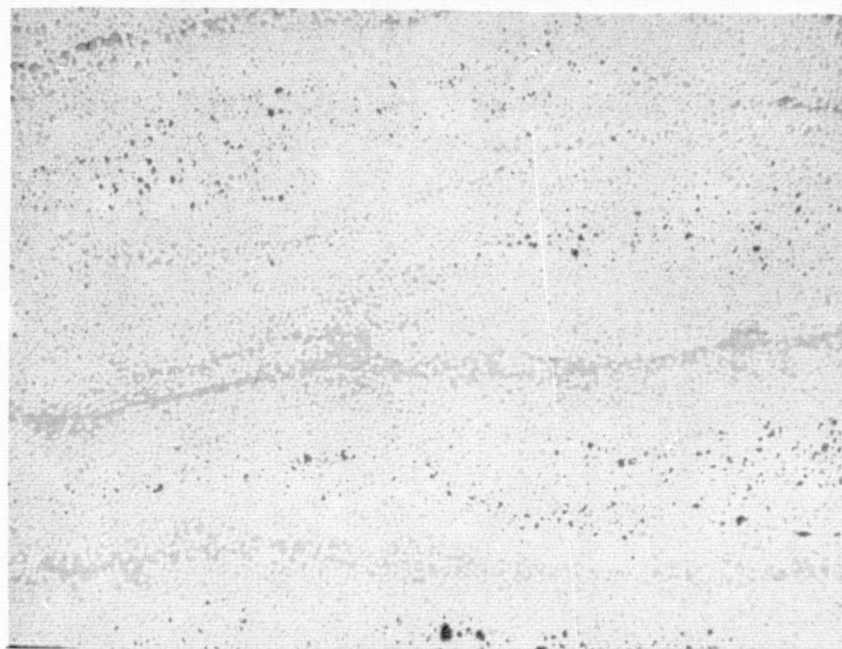
OPTIMIZED HMS/360 POLYARYLSULFONE COMPOSITE

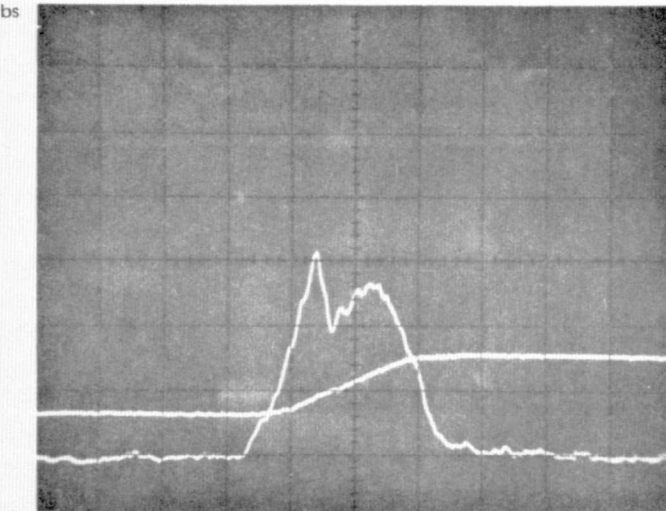
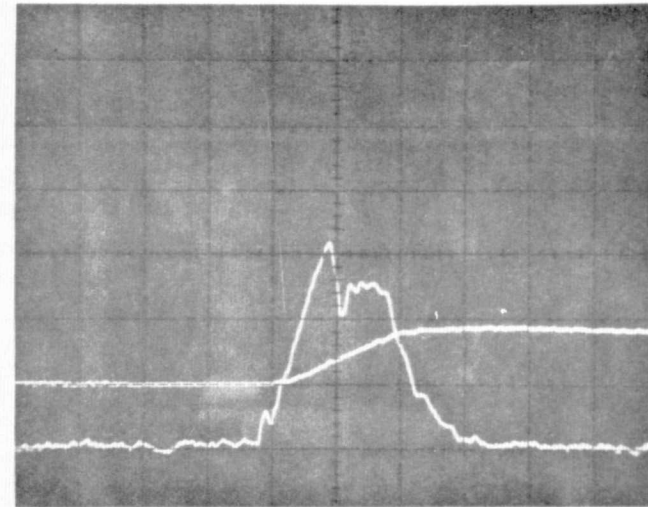
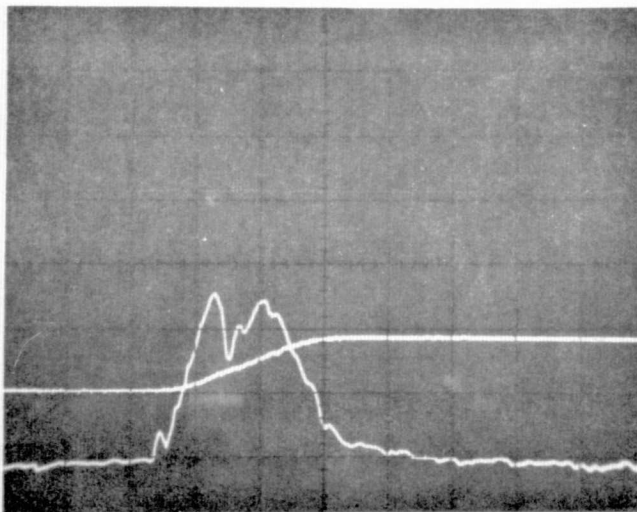
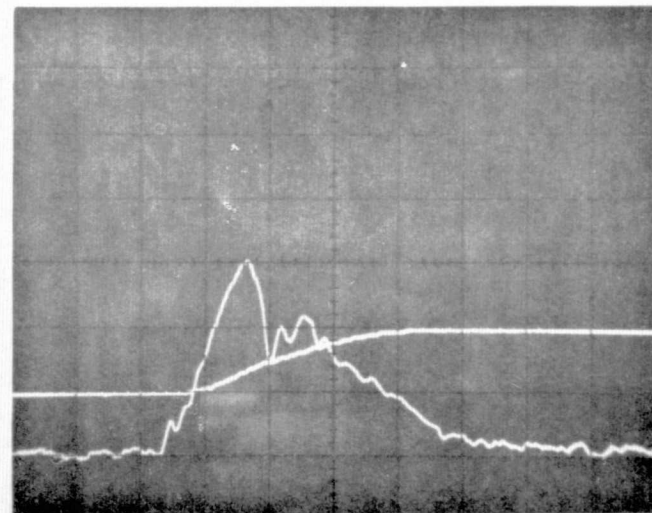
FIG. 17

# HMS/P1700 POLYSULFONE THIN PENDULUM IMPACT TESTS

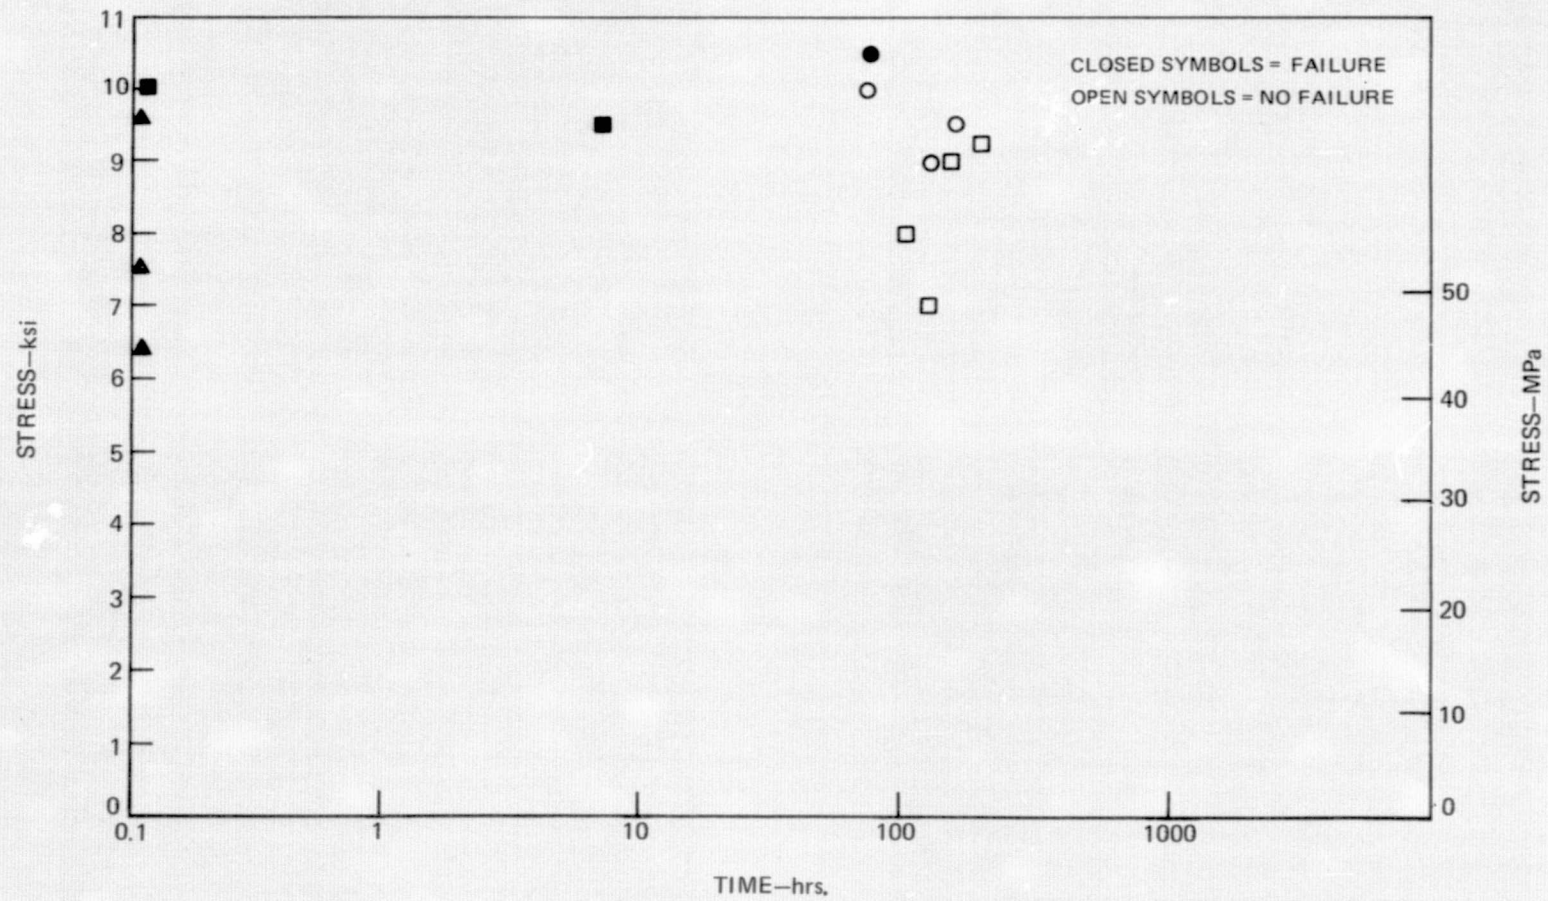
FIG. 18

# HMS/P-1700 POLYSULFONE STRESS-RUPTURE AT 122°C

± 45° ORIENTATION

The tensile tests of laminates in a  $\pm 45^\circ$  configuration showed that the material did not have structural capability at 163°C. As a result stress-rupture tests were carried out at the 122°C and 149°C temperatures. The data from the tests are presented in Figs. 18 and 19 in terms of initial stress versus time at that stress. Darkened symbols indicate failure, while open symbols indicate no failure. Different symbols (triangles, circles, squares) indicate different laminates from which the specimens were cut. This latter indication was made because some of the laminates produced lower strength specimens than others; in particular the laminate used to measure the static properties shown by the triangles was of low strength. This was unfortunate because it resulted in several runouts at the 100 hour period of interest since stress levels were based on static strengths. This was especially true for the 122°C tests. Nevertheless enough tests were conducted to obtain good estimates of the 100 hour stress-rupture limits. At 122°C a stress of approximately 69 MPa (10 ksi) could be sustained for 100 hrs, while at 149°C the comparable stress was 29 MPa (4.3 ksi).

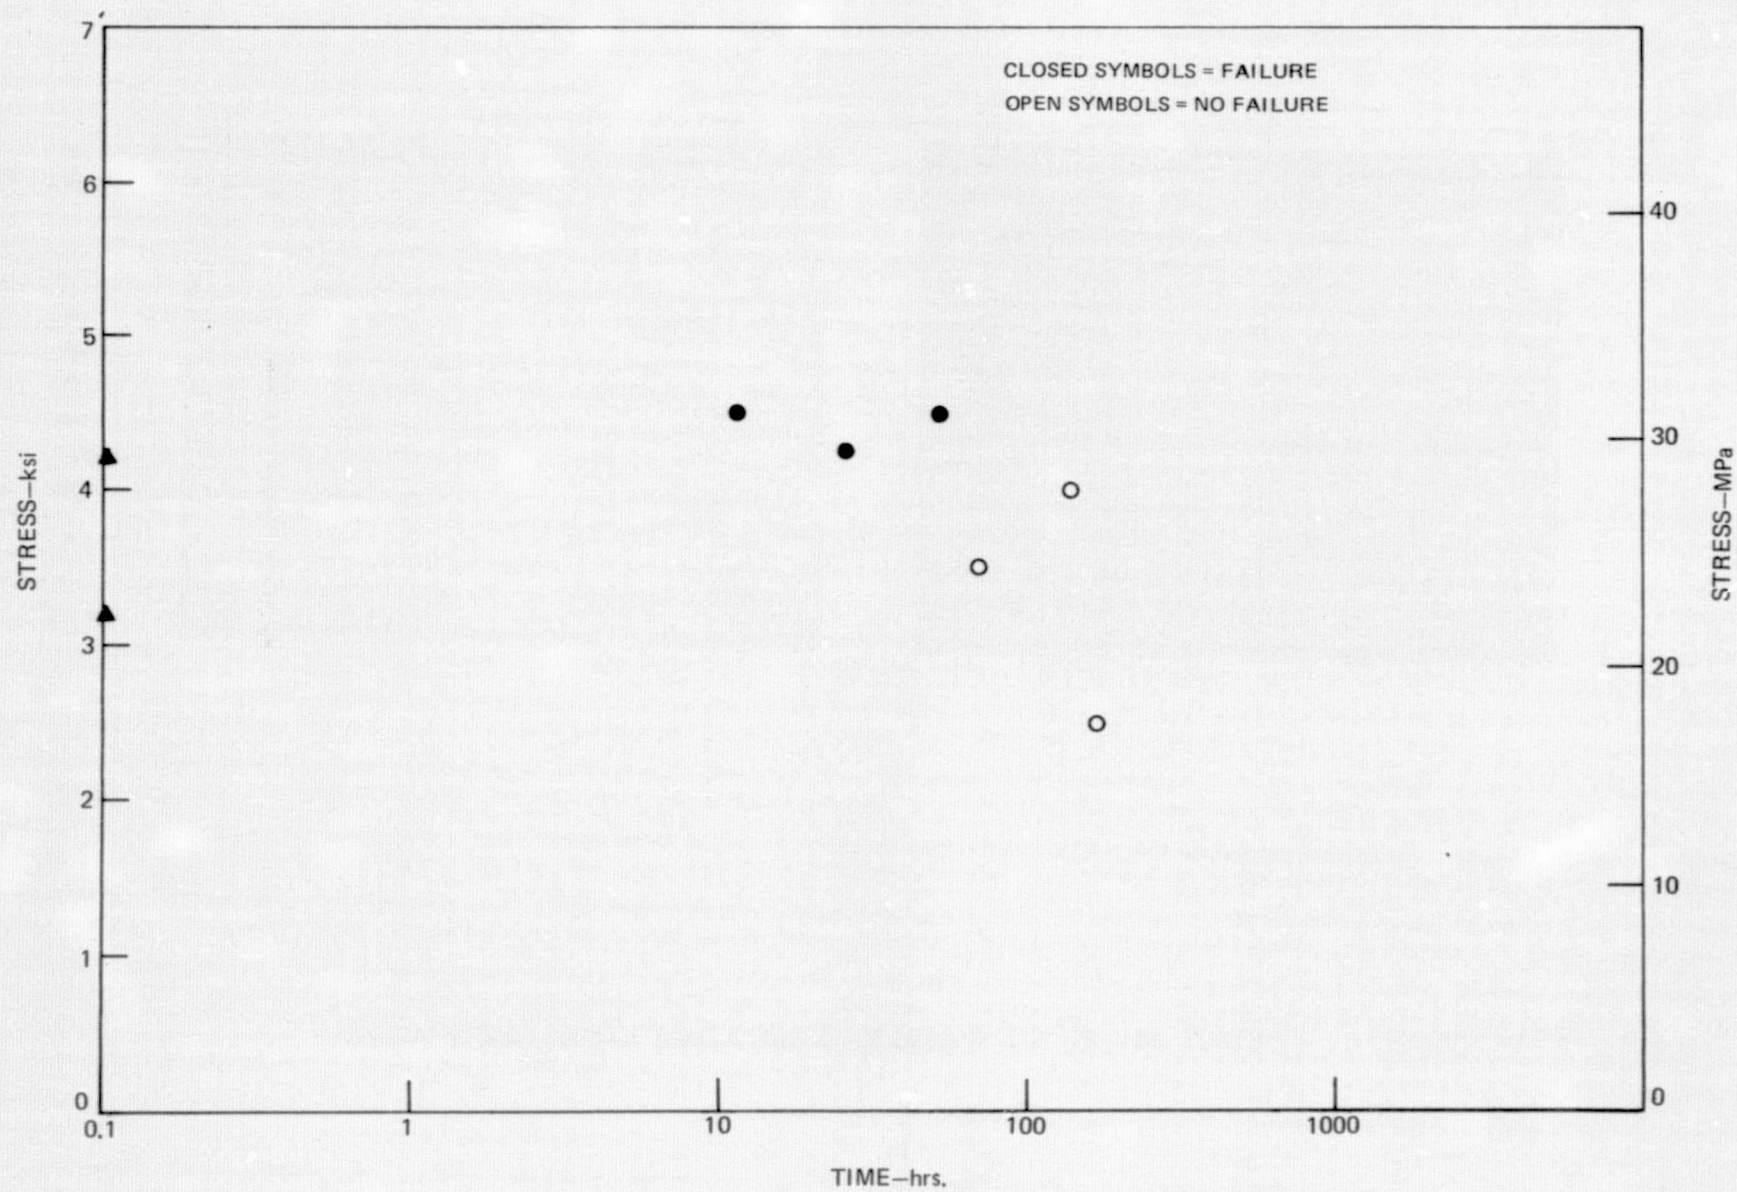
FIG. 19

# HMS/P-1700 POLYSULFONE STRESS-RUPTURE AT 149°C

± 45° ORIENTATION

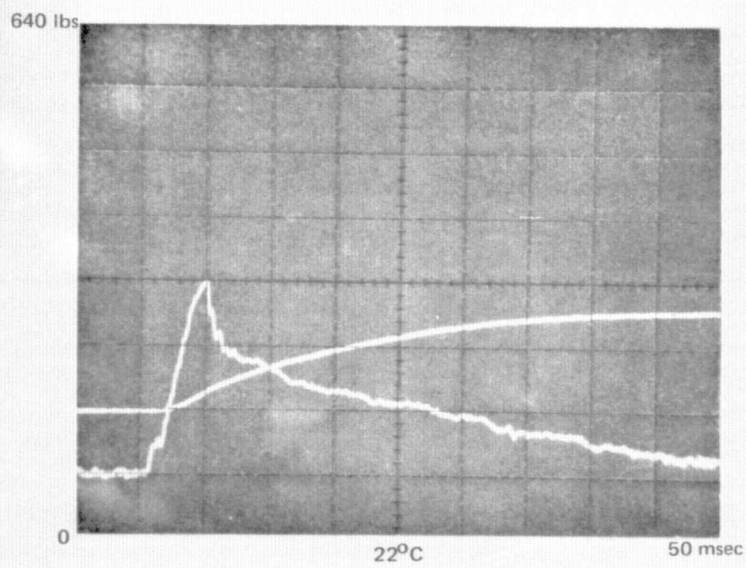
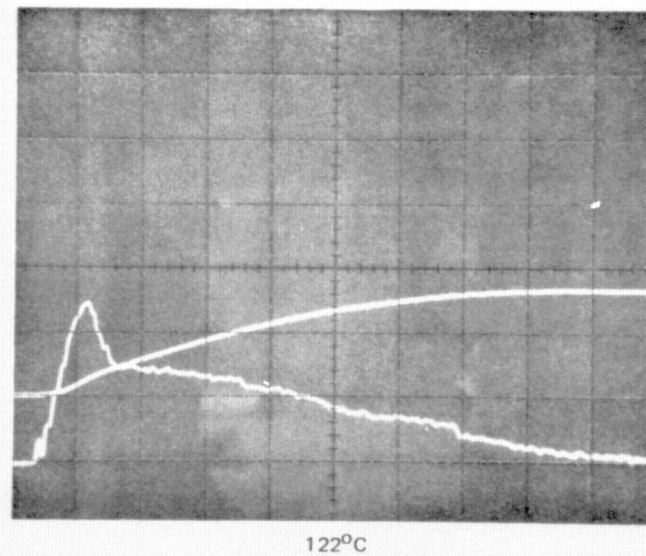
FIG. 20

# HMS/GLASS/P1700 POLYSULFONE THIN PENDULUM IMPACT TESTS

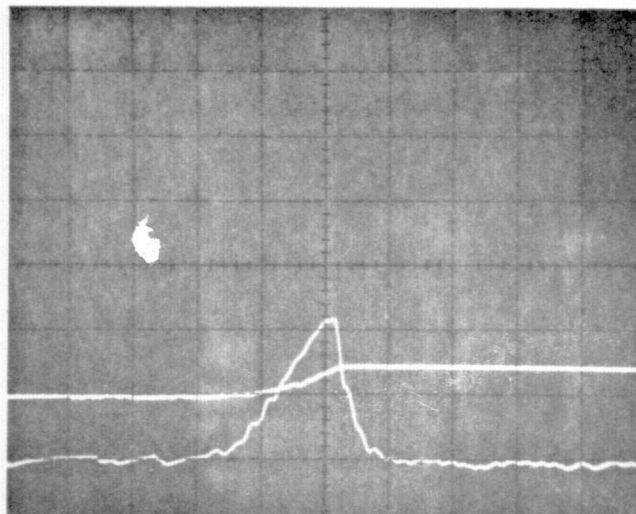
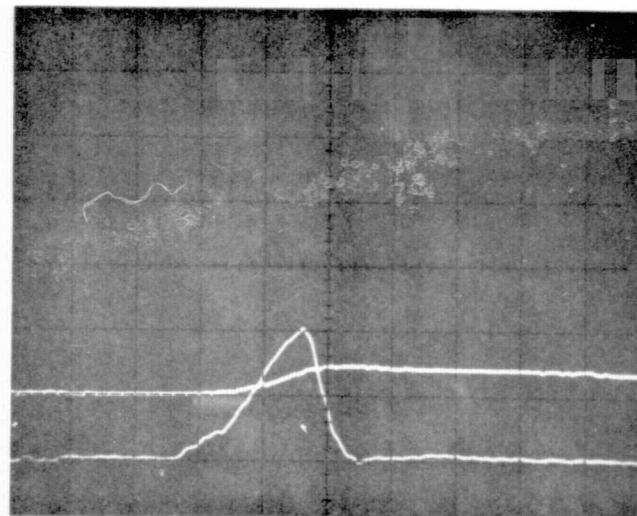
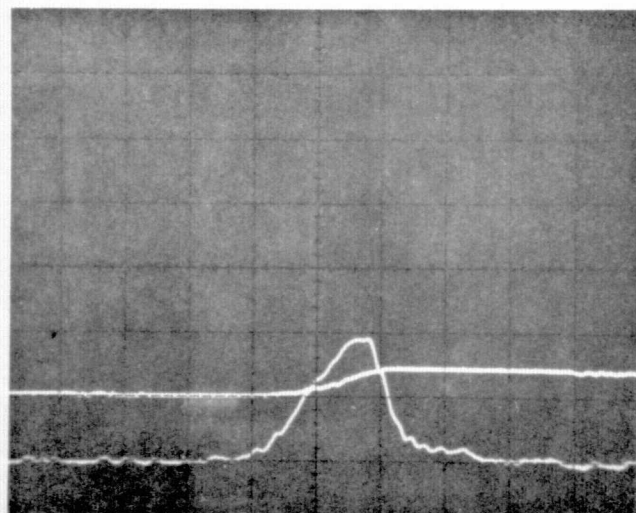
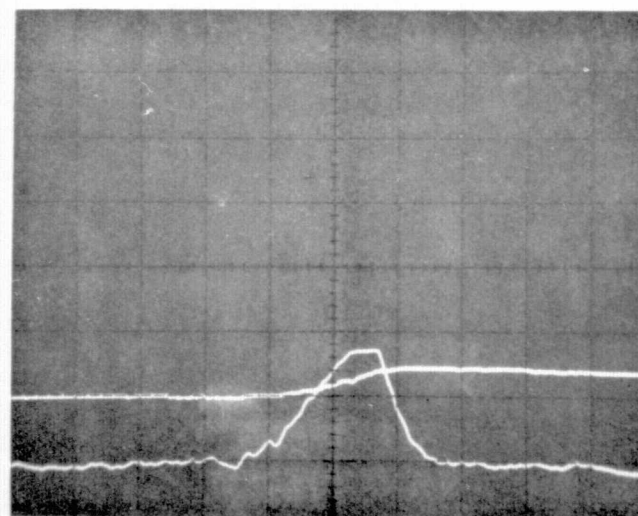
FIG. 21

# HMS/300 P POLYETHERSULFONE THIN PENDULUM IMPACT TESTS
